## **INVESTIGATION OF MECHANICAL FAILURE OF STABILIZER ROD OF USED VEHICLE: A CASE STUDY OF NISSAN XTERRA VEHICLE**

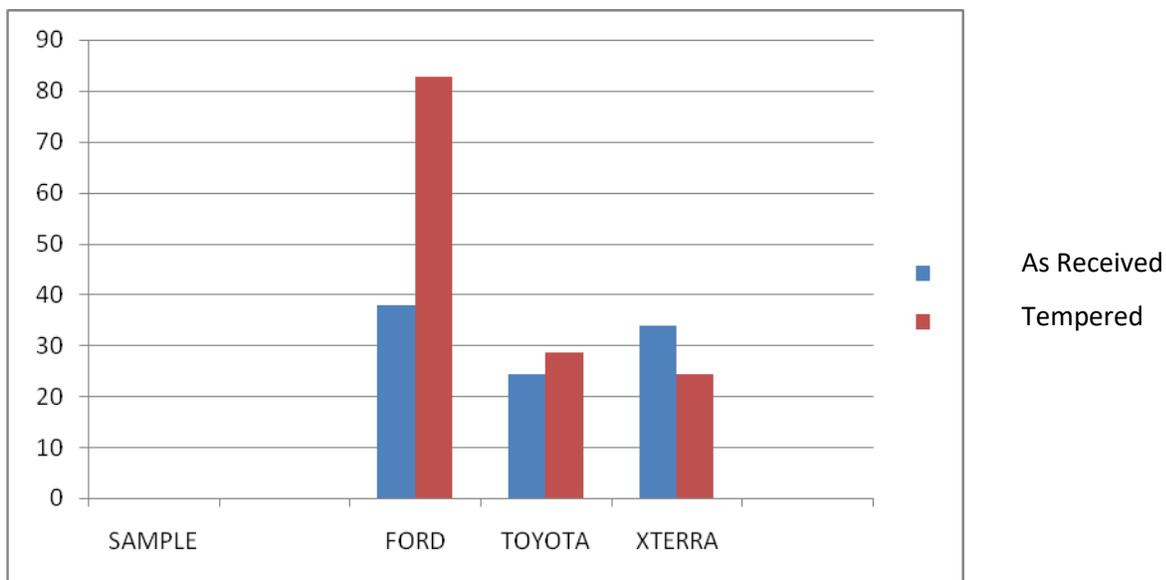
**Fig. 3.2** Graph showing Impact Strength of different Stabilizer Rods

Other elements like vanadium, chromium and silicon in combination with other elements also helps to increase toughness. Manganese which is detrimental to toughness is highest in Xterra 0.753 wt%. Sulphur and phosphorus are other detrimental elements to toughness and should be maintained at minimum levels. The wt% of phosphorus is highest in Xterra 0.268 wt%, the impact test results shows that Ford has the highest impact energy of 37.96J, followed by Xterra 33.90J and Toyota 24.40J.

The impact test results of the heat treated samples are as shown in Table 3.2 and their corresponding microstructure in Fig. 3.1(d-f). Comparing the results of the impact strength as obtained and heat treated samples, it is observed that the impact strength of the Ford increased when heat treated to 82.71J, Toyota increased to 28.47J but Xterra was observed to have reduction in impact strength when heat treated to 24.40J. These changes in impact strength were also shown in the microstructures observed in Fig. 3.1(d-f). The slight increase in impact strength of the heat treated Toyota sample from the microstructure observation shows that there was reduction in spherical cementite in the ferrite matrix.
