A RESEARCH ON ACCESSIBILITY OF URBAN PARKS BY DISABLED USERS

In this study, one of the largest parks in Konya for disabled people were examined and evaluated. Parking available in the area, walking paths, plantings and urban equipment of the

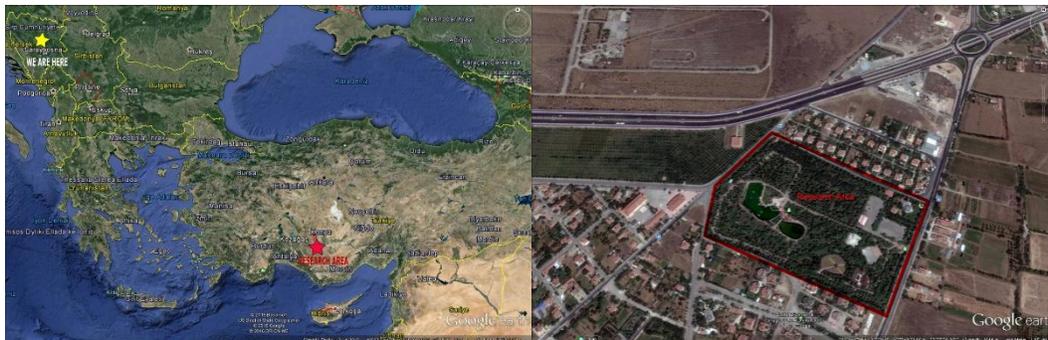
Figure 1 (a) Satellite view of the research area (b) Google map view of research area

The study area takes place in the city of Konya, town of Meram, Kozagac District, Hatip Street. The total area is 104.000 square meters (Figure 1 a and b). There are three buffets, two cafeterias, one mini football pitch, one volleyball field, one basketball field, 24 fitness sport equipment, one child game area, one chess game area, amusement park, one animal shelter, one sport facility, one poultry zoo, one aster park and also a pond of 20.000 m² area in the study area.

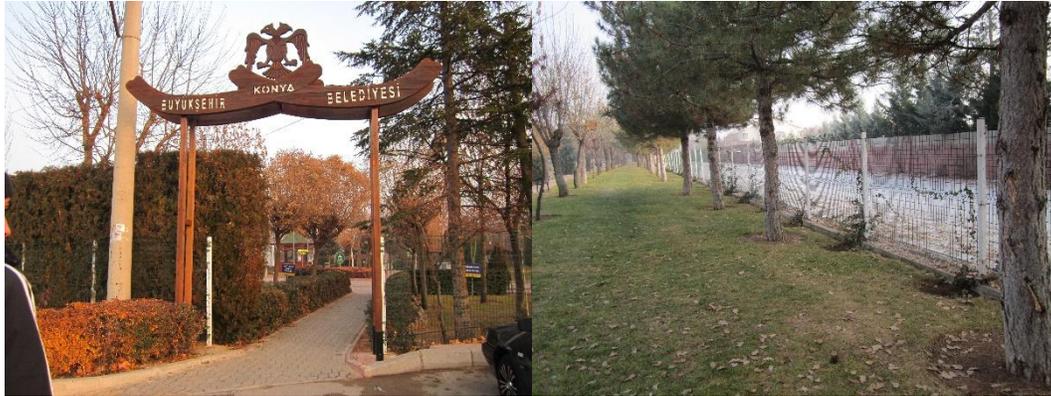
There are two entrance points providing the entrance to the study area from different directions. The use of entrance points is obligatory due to the fence surrounding the area, one point is both vehicle and pedestrian entrance and the other entrance door is only for the pedestrian usage figure 2 (a). The width measurements of both entrances of the area is in sufficient amount according to the user density and ramp arrangements have been made in the convenient measurements in the places having slope difference.

Figure 2 (a) Park pedestrian entrance door (b) Fence

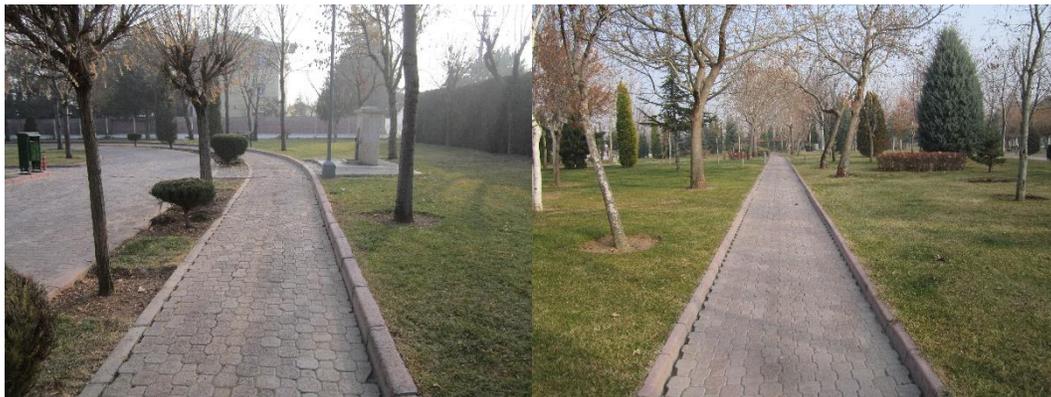
Figure 3 Park pedestrian way

The width of one of the two walking ways starting from the entrances of the area and continuing in parallel is 400 cm and the width of the other one is 150 cm. The width of the walking way continuing through the inside of the park is 160 cm. according to TSI 12576 [8], the pedestrian pavement should be at least 150 cm for all the pedestrians to be able to move freely. This distance has been determined as 200 cm as the most ideal by the Prime Ministry Administration for Disabled People [5]. According to [9], the distance necessary for two wheel chairs to be able to pass the road bilaterally is 150 cm. Within the direction of these standards, two walking ways is deficient according to [5] because they are below 200 cm. However; they are convenient for general usage (Figure 3). Paving stone has been used as the coating material on the walking ways in the area. Although paving stone is seen as an ideal material with its economic, aesthetic and enduring properties, the width between the stones to be above 2 mm and the formation of elevation differences between the stones during the laying form negativities for the handicapped individuals.

The surroundings of the obstacles such as sheet dustbin etc. taking place on the way have not been specified with perceivable / sensible surfaces and colors or there is no guiding structure or strips that will enable the visually handicapped people to find their routes and directions in the walking ways taking place with different stimulatory elements. According to the standards taking place in TSI 12576 [8] for the visually handicapped people to be able to move comfortably alongside the walking ways taking place in the area, it is necessary that the illumination elements, sheets and plant ceiling heights taking place alongside the walking ways should be at least 220 cm. Within this scope; it is not in accordance with the standards, because the ceiling height of the trees taking place on the walking way is 190 cm.

*The material of the pedestrian ways should be replaced with a convenient material and walking strips should be formed for especially the visually handicapped individuals to be able to follow the way with their walking sticks.

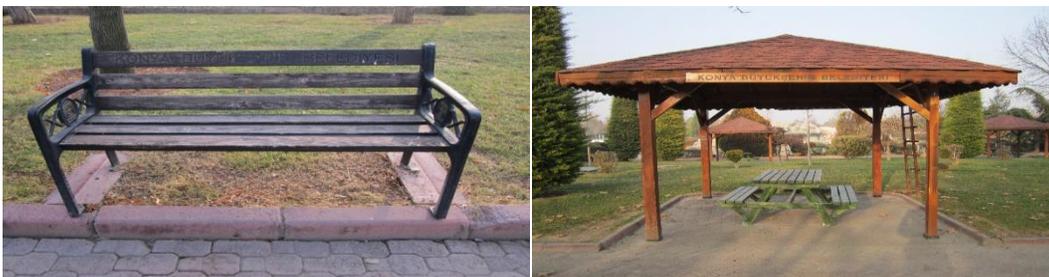
Figure 4 (a) Bank of the park

(b) Camellia and bank

The height of the banks being one of the sitting elements taking place in the study area from the ground has been measured as 45 cm. This height is not convenient because the maximum height is 45 cm. The width of the sitting places of the banks is 42 cm. It is quite convenient when the standard being 38 cm is considered. There is no distance near the banks and that is necessary for the wheel chair to comfortably approach here. There are places necessary for two handles to take support near the banks (Figure 4 a).

The heights of the different sitting units taking place within the area from the ground are not convenient for the handicapped individuals. The minimum depth below the table should be 60 cm for the individuals using wheel chair to be able to approach the sitting individuals from all the directions. The heights of the sitting places from the ground and the sitting widths are in accordance with the standards, the camellia entrance width is not in accordance with the standards (Figure 4 b).

*Areas should be formed near the sitting elements in the sitting areas in which the wheel chair users could also take place.

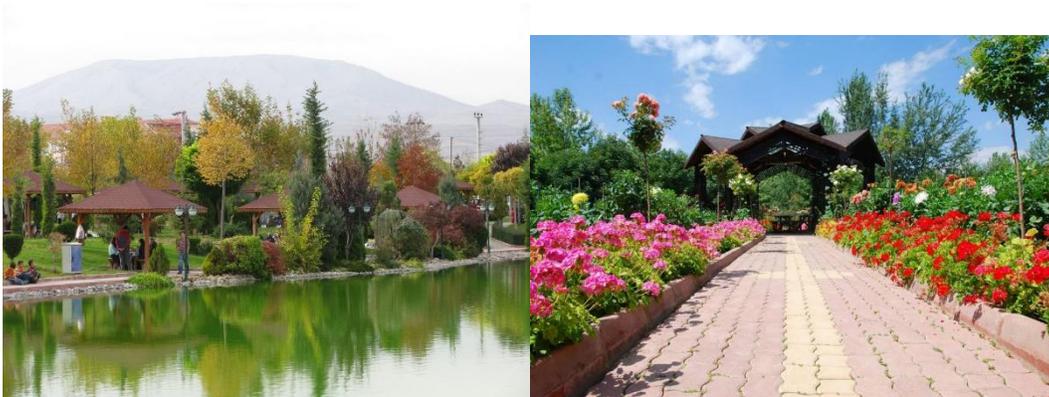
Figure 5. Vegetation samples from Konya Kozagac Park

There are plants with 3500 leaves and 2300 evergreen and in many different species within the study area alongside the walking ways; most of these plants are not in sufficient distance to the way and because the branches of most of them come up to the walking way, they pose threat. The surroundings of the plants have not been elevated with a platform and their surroundings have not been limited by a different material. There are no strips or protection separating the walking ways from the green area and that may be felt by the visually handicapped people.

The branches of some plants taking place alongside the walking ways in the area come up to the walking ways. The pruning and maintenances of the plants taking place alongside the walking ways should be regularly made in terms of not giving any damage to especially the visually handicapped individuals.
